# A358 Taunton to Southfields Dualling Scheme

## Ecological Baseline Report - River Corridor Survey (RCS) and Macrophytes

HE551508-ARP-EBD-ZZ-RP-LE-000024

24 May 2022

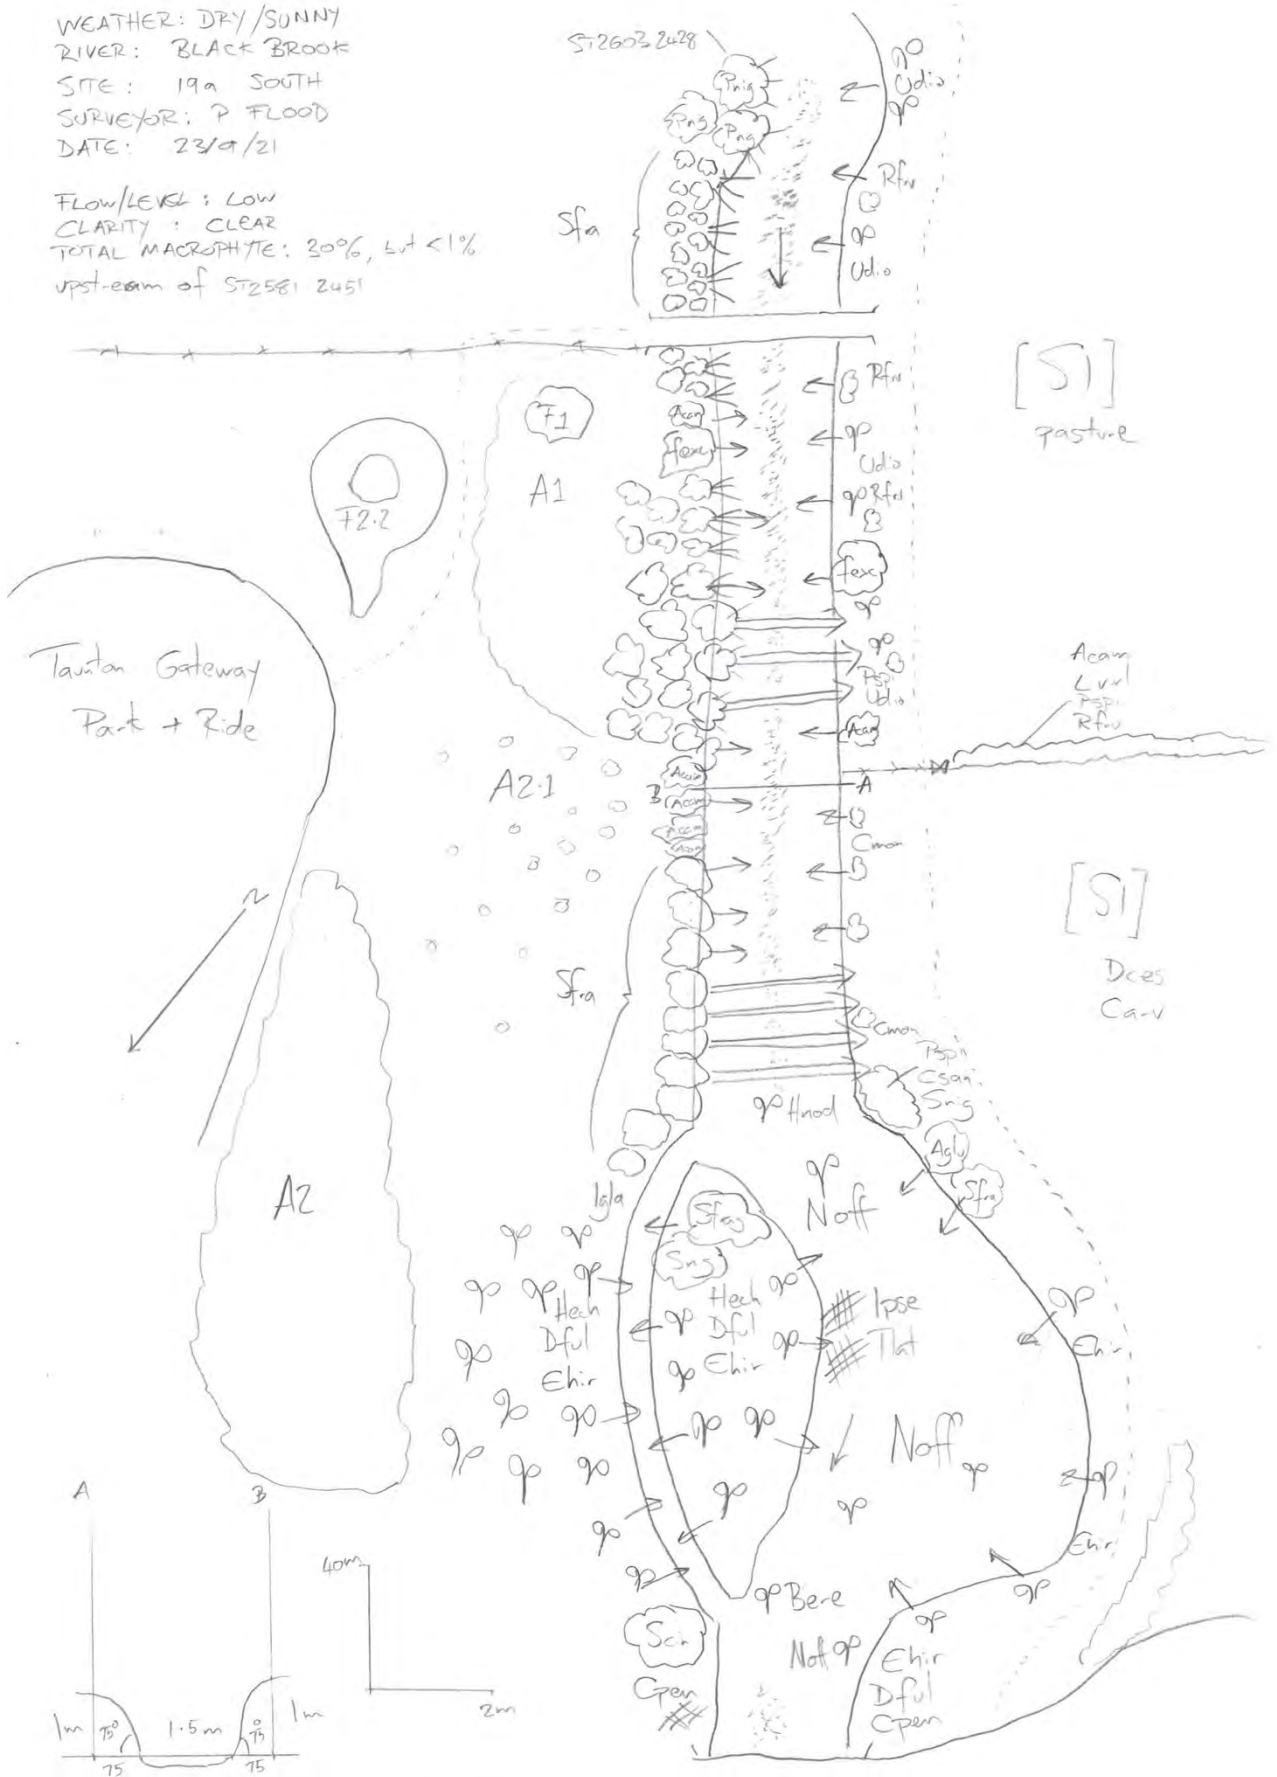
Figure B-4 RCS map - Site 19a - South of A358 scheme crossing

WEATHER: DRY/SUNNY  
 RIVER: BLACK BROOK  
 SITE: 19a SOUTH  
 SURVEYOR: P FLOOD  
 DATE: 23/9/21

FLOW/LEVEL: Low  
 CLARITY: CLEAR  
 TOTAL MACROPHYTE: 30%, Lt < 1%  
 upst-ream of ST2581 2451

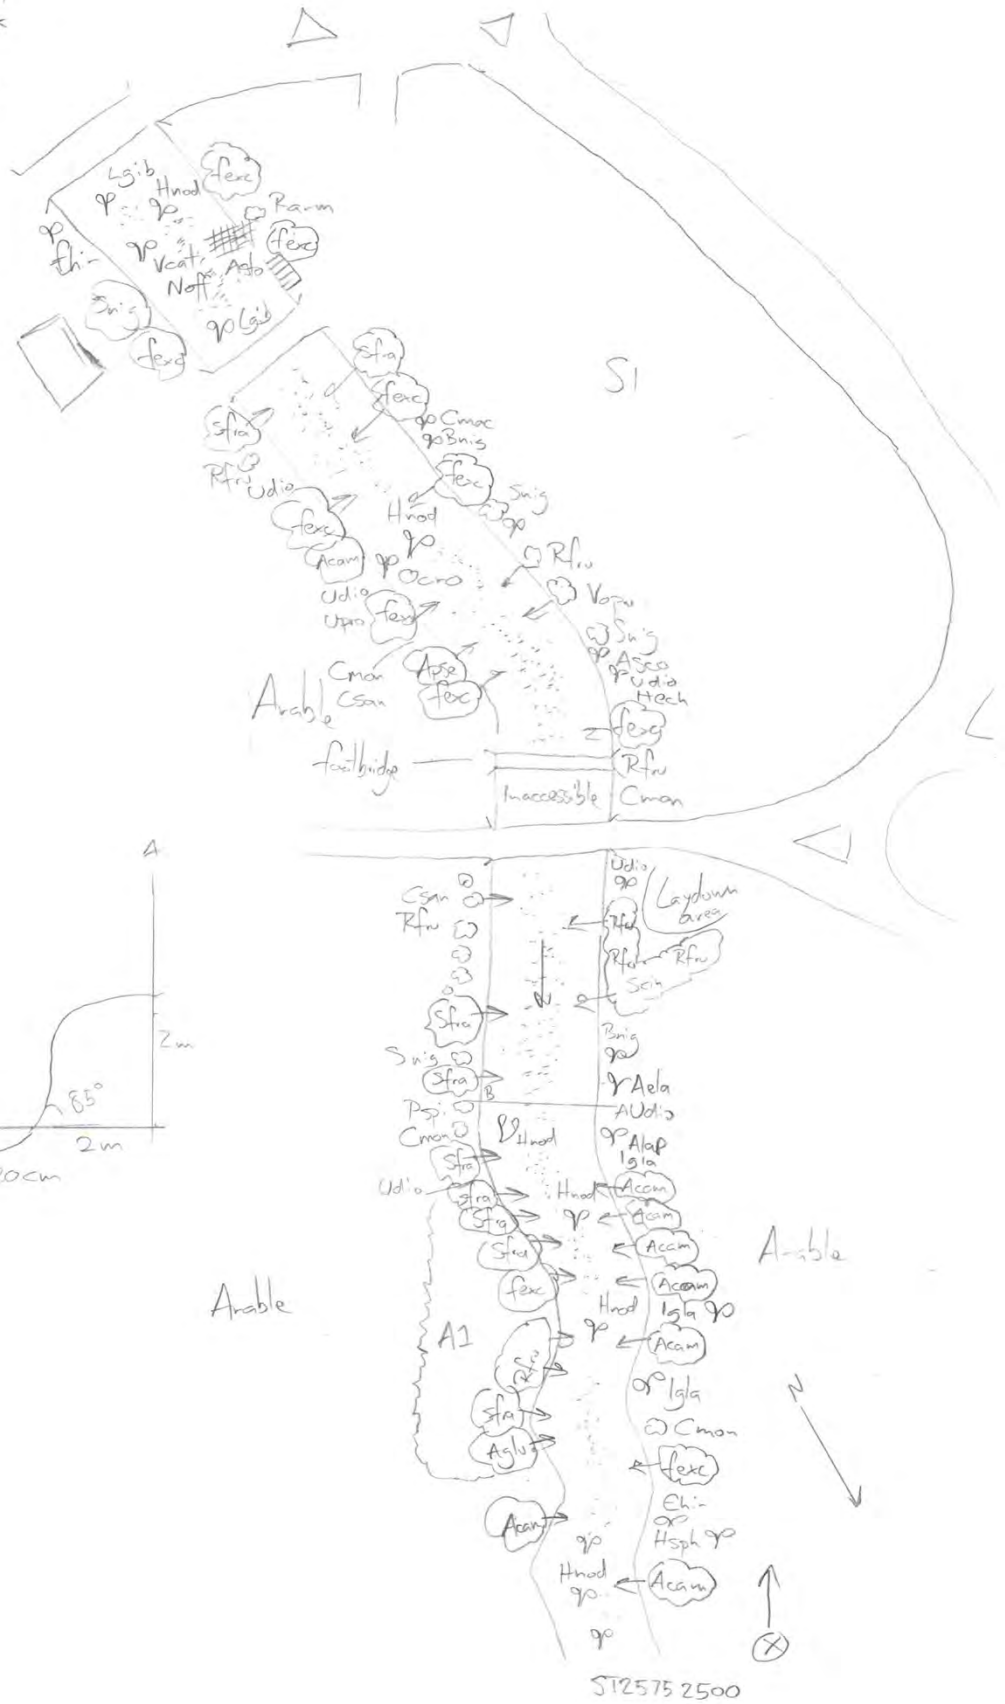
Figure B-5 RCS map - Site 19a - North of A358 scheme crossing

- 3.2.19 The river channel at site 19a north comprises a plunging and u-shaped channel along the northern half of the reach where it traverses arable land, suggesting regular dredging. The bank profile has a gentler gradient south of the footbridge, which was observed towards the upstream extent of the survey reach (at NGR: ST 2603 2428). The channel was choked with vegetation and visibility was low, but it was appeared silty with little perceptible flow for its entire length. Where it crossed the road network, the watercourse had been extensively modified and straightened but the northern extent of the study area had a few small meanders. The river channel appeared to be ephemeral, despite its many tributaries.

WEATHER: DRY/SUNNY  
 RIVER BLACK BROOK  
 SITE 19a NORTH  
 SURVEYOR P FLOOD  
 DATE: 23/9/21

FLOW/LEVEL: LOW  
 CLARITY: CLEAR  
 TOTAL MACROPHYTE  
 COVER: 30%
