# A358 Taunton to Southfields Dualling Scheme

## Ecological Baseline Report - Water Vole

HE551508-ARP-EBD-ZZ-RP-LE-000015

24 May 2022

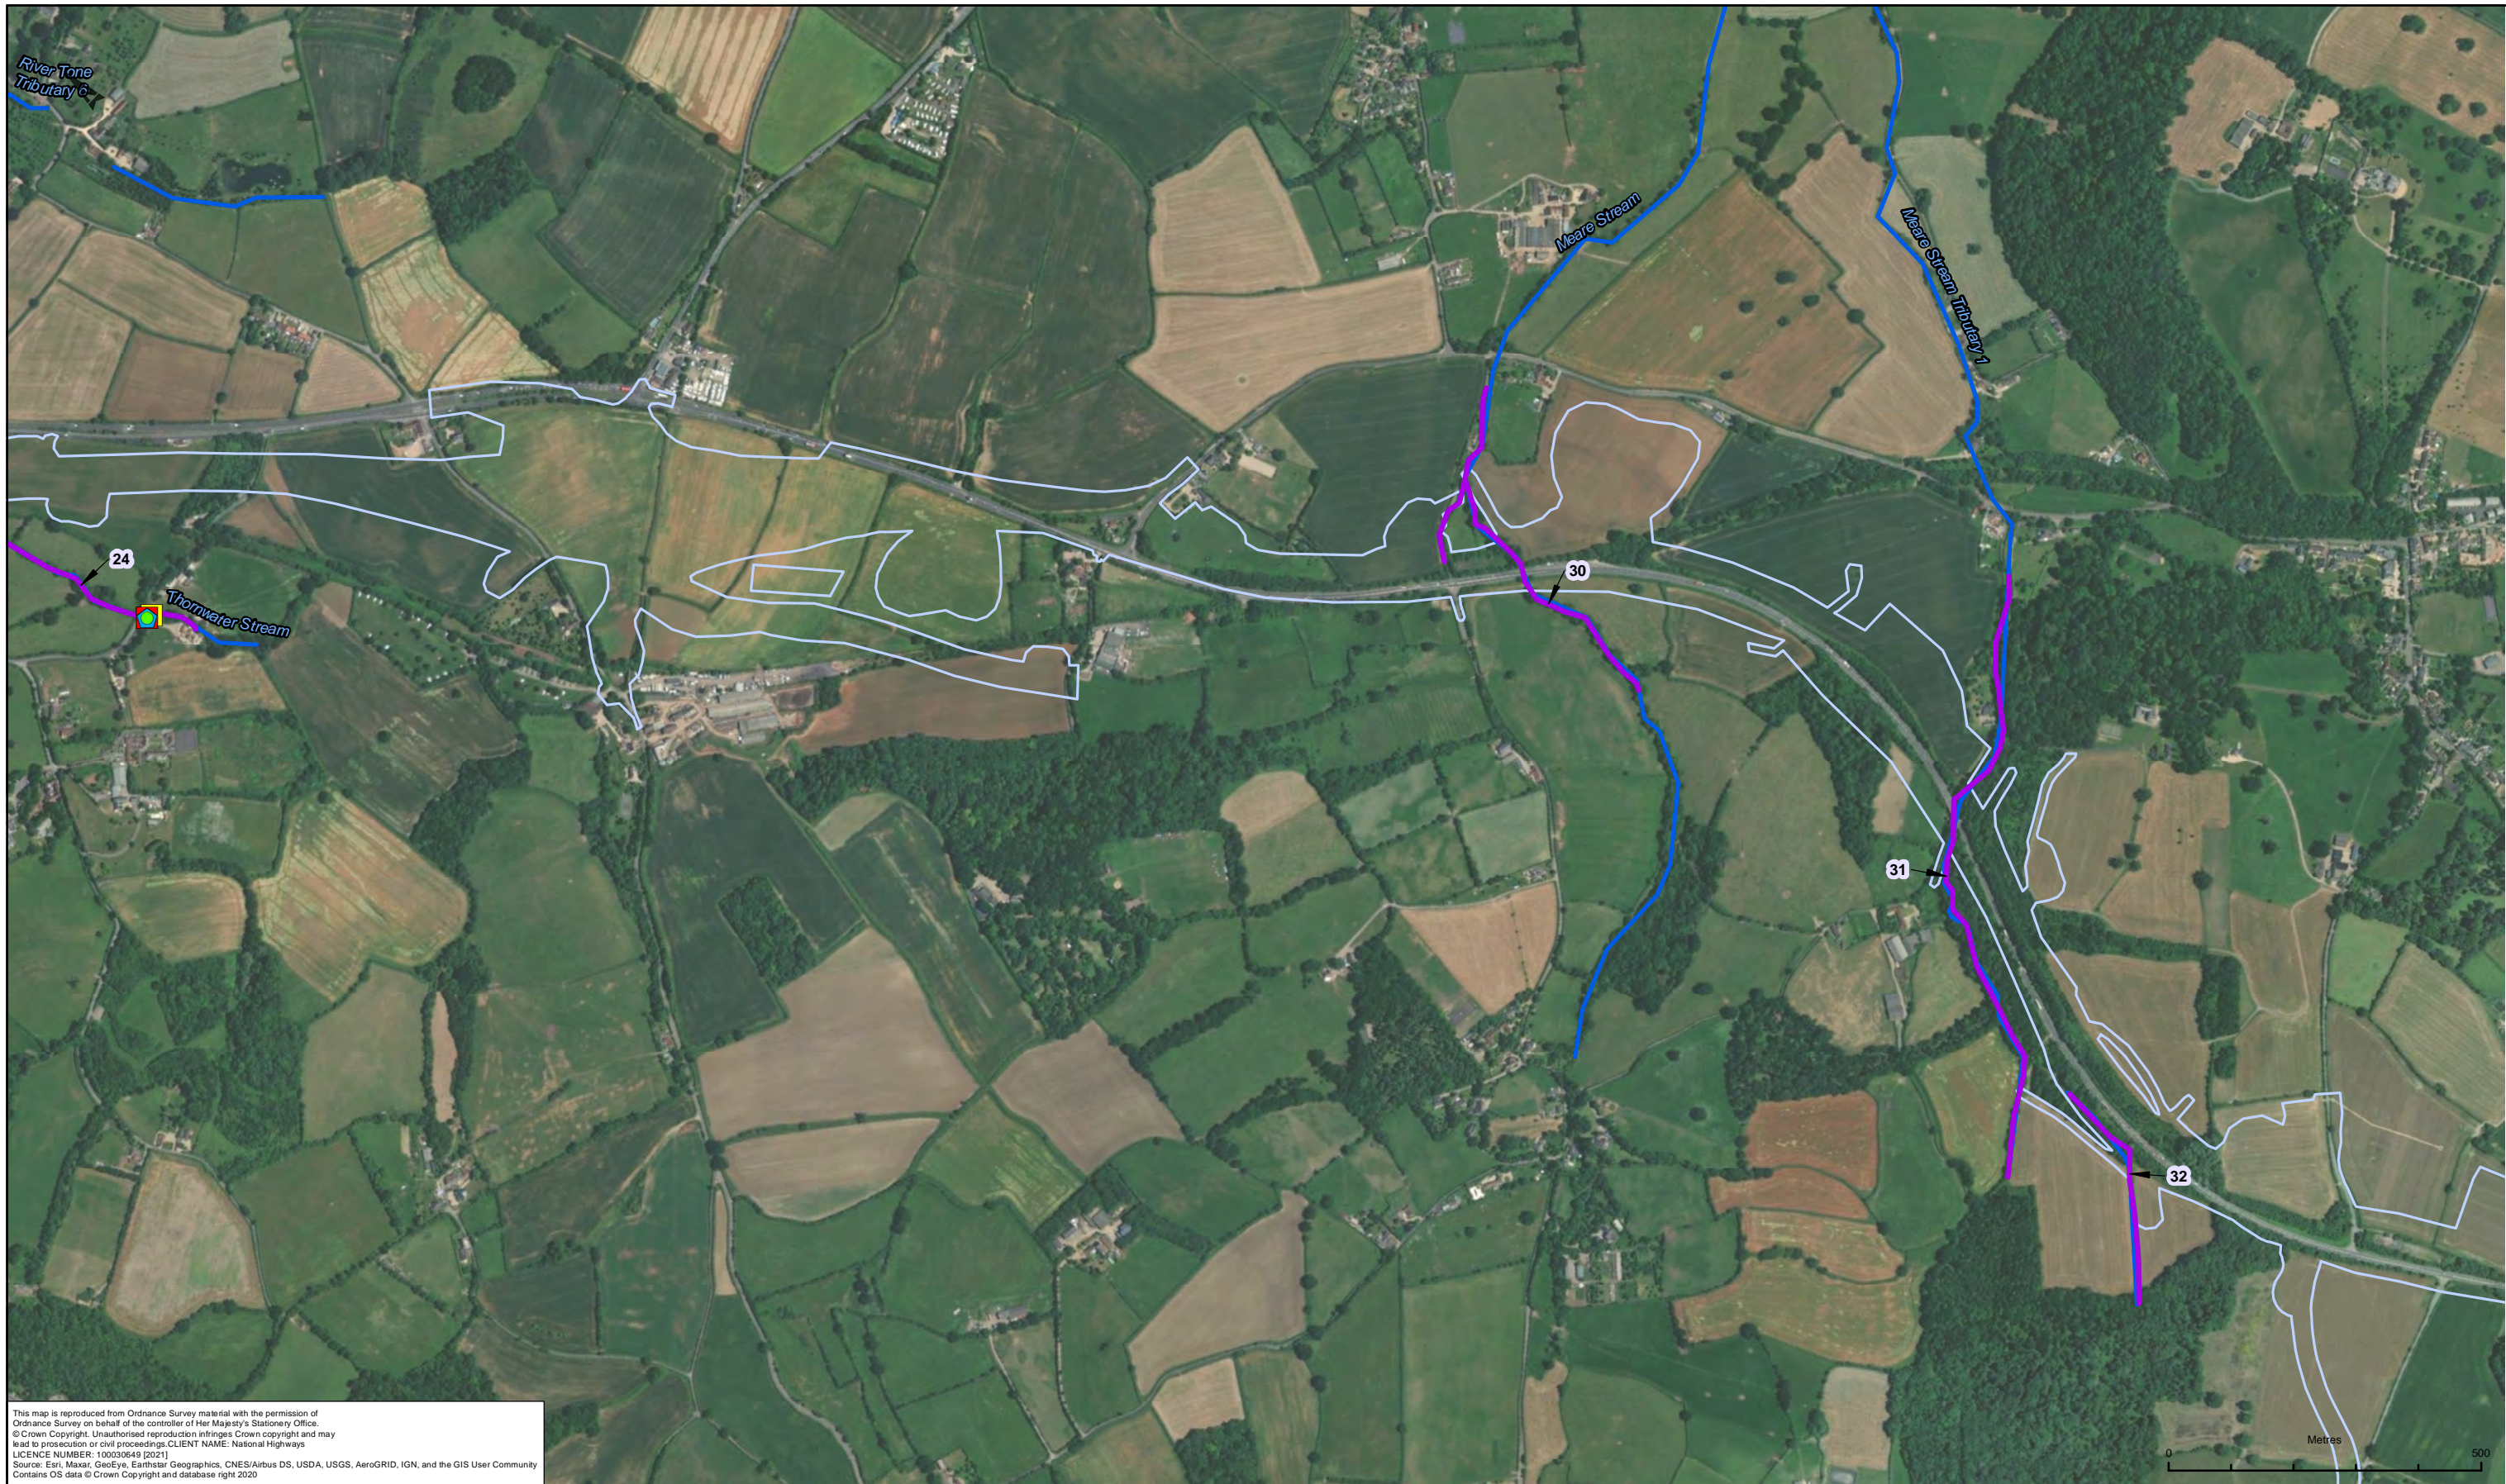
- LATRINE
- + FOOTPRINTS
- ⬠ FEEDING STATION
- CONFIRMED BURROWS

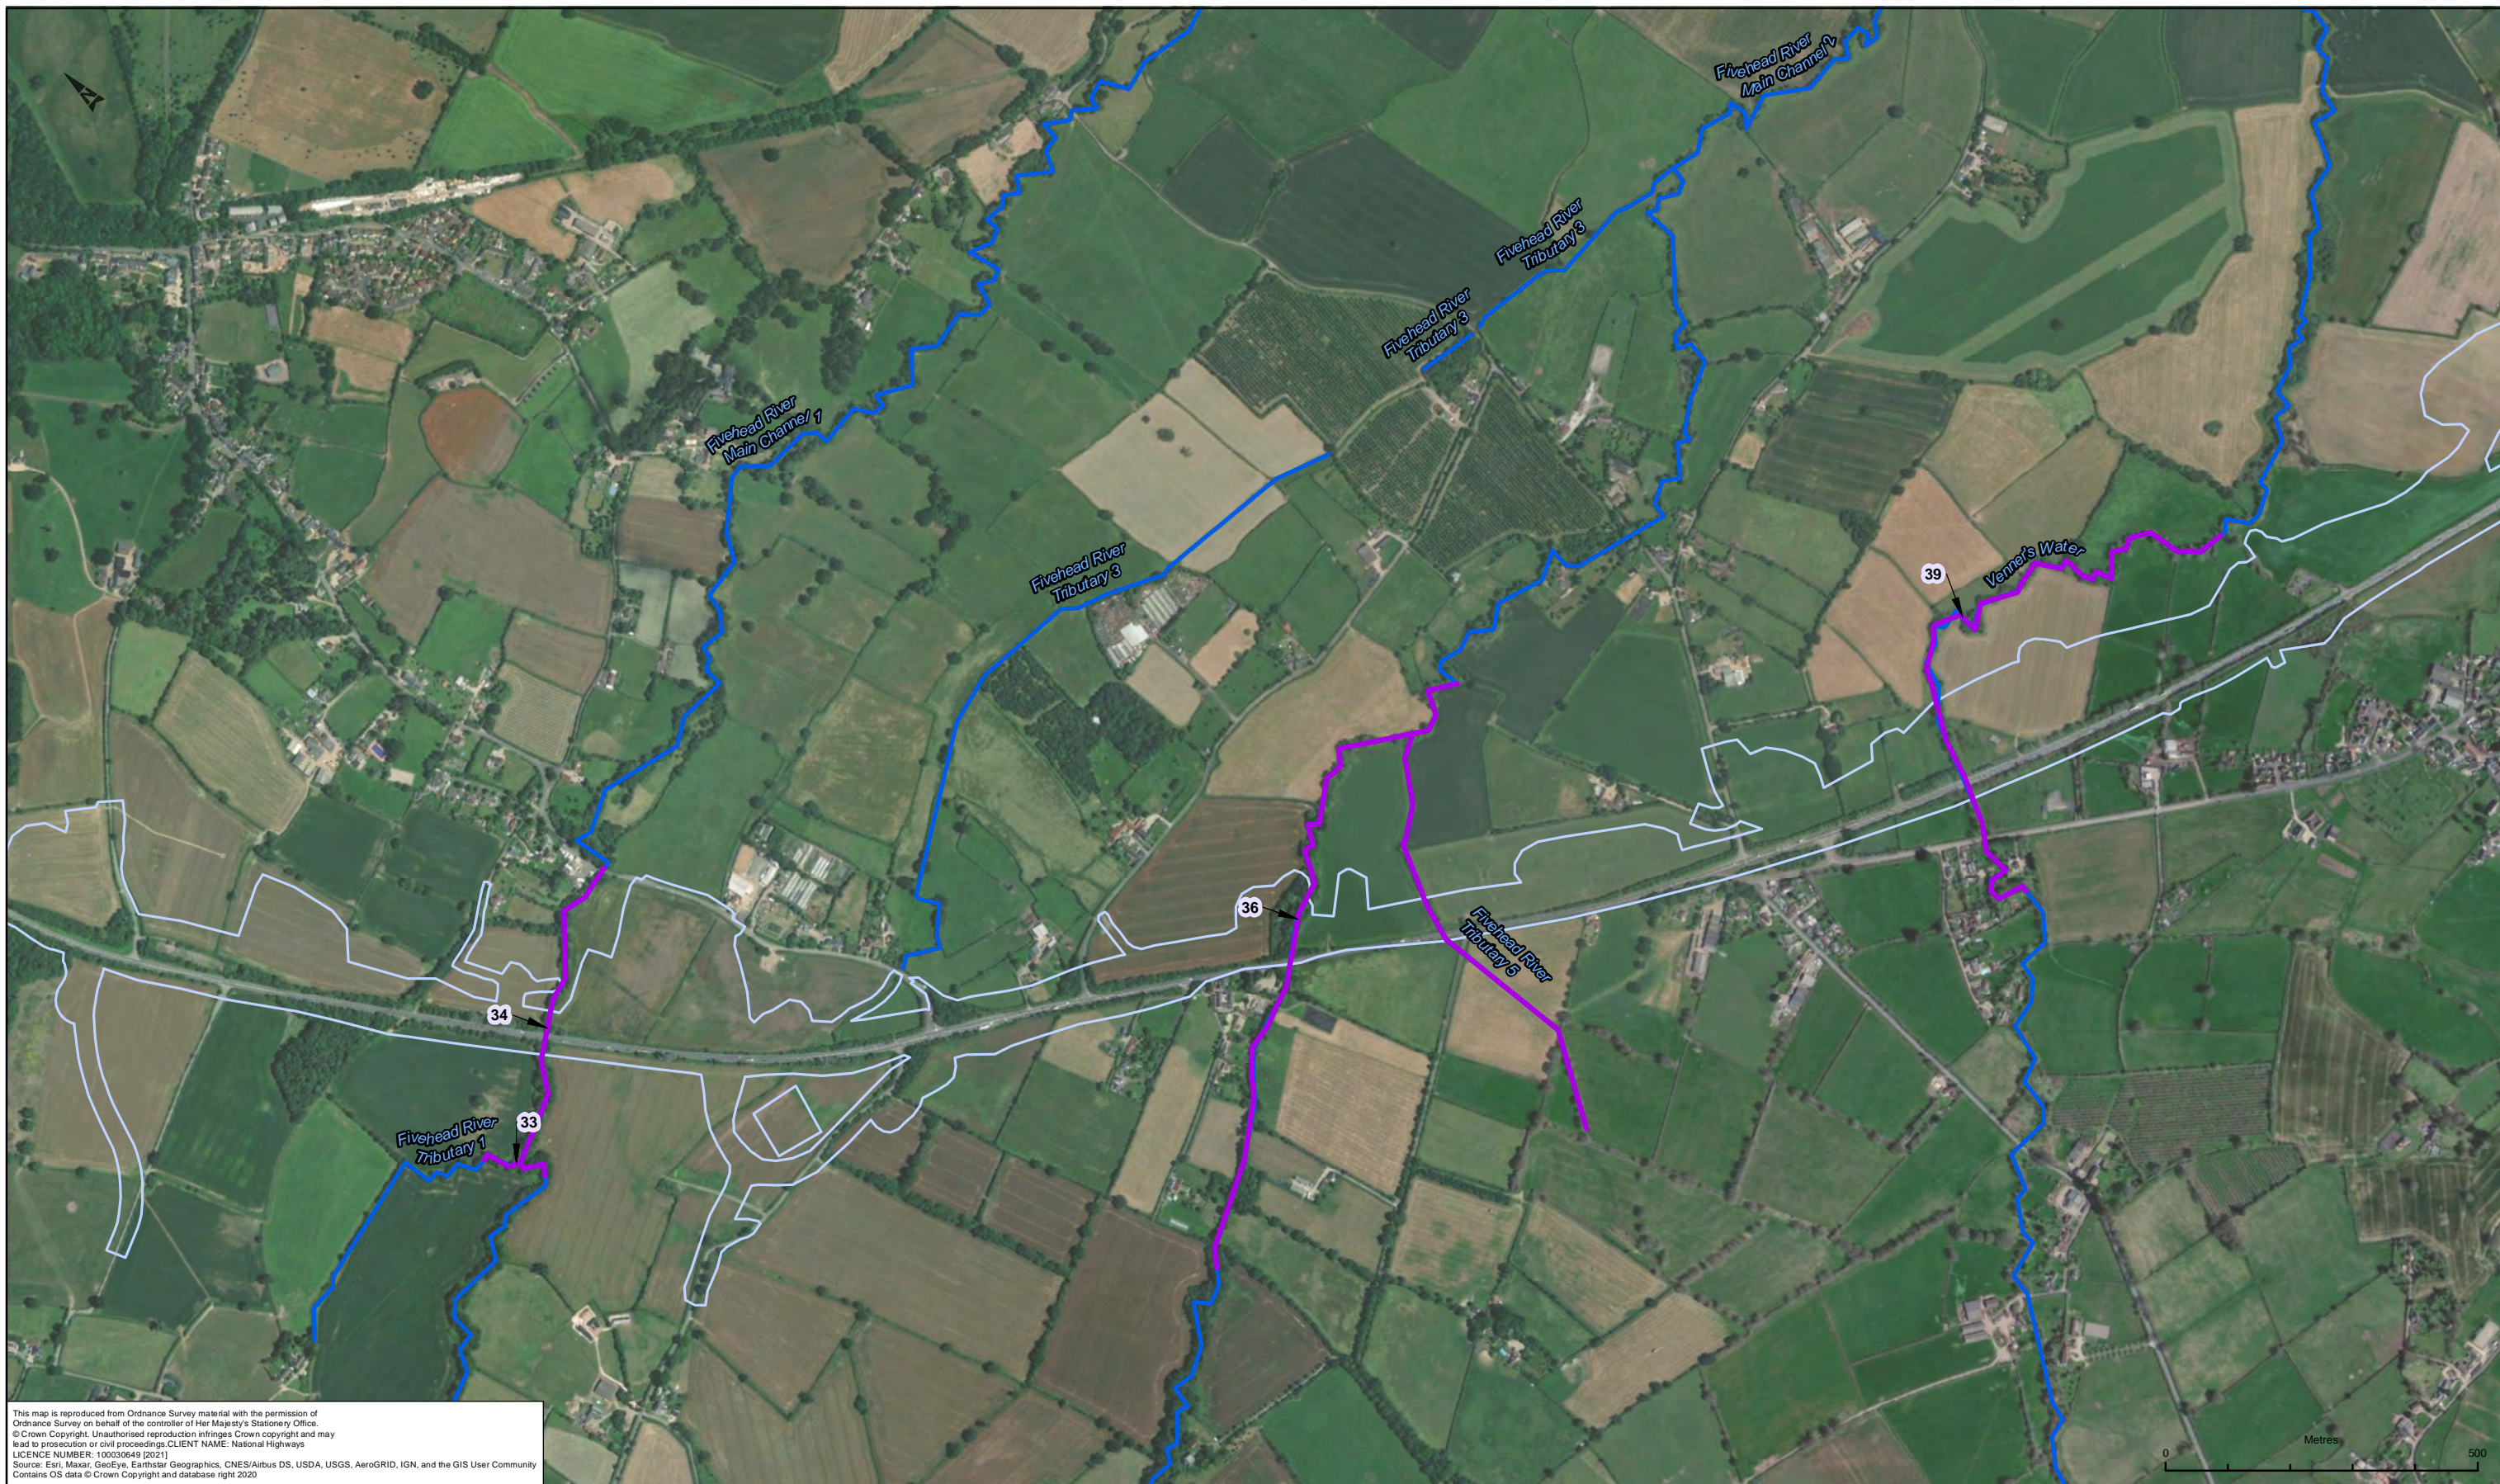
- LATRINE
- + FOOTPRINTS
- ⬠ FEEDING STATION
- CONFIRMED BURROWS
